NUMBER
14-AT-003
GROUP
AUTOMATIC TRANSMISSION

DATE
FEBRUARY, 2014
MODEL
Tucson (LM), Santa Fe (CM/AN/NC),
Sonata (YF/YF-HEV), Elantra
(UD/MD/GD/JK), Accent (RB), Azera
(TG/HG), Veloster Turbo (FS)
AUTOMATIC TRANSAXLE SOLENOID DTC

SUBJECT:
P0741, P0743, P0748, P0753, P0758, P0763, P0768, P0773, P1778 & P2709
This TSB supersedes bulletin 13-AT-008 to revise the Service Procedure, Steps 5, 19, 28 and 29.
Description:
Do not replace the transmission for solenoid DTC listed above. Instead, follow the repair procedure and replace the related part.

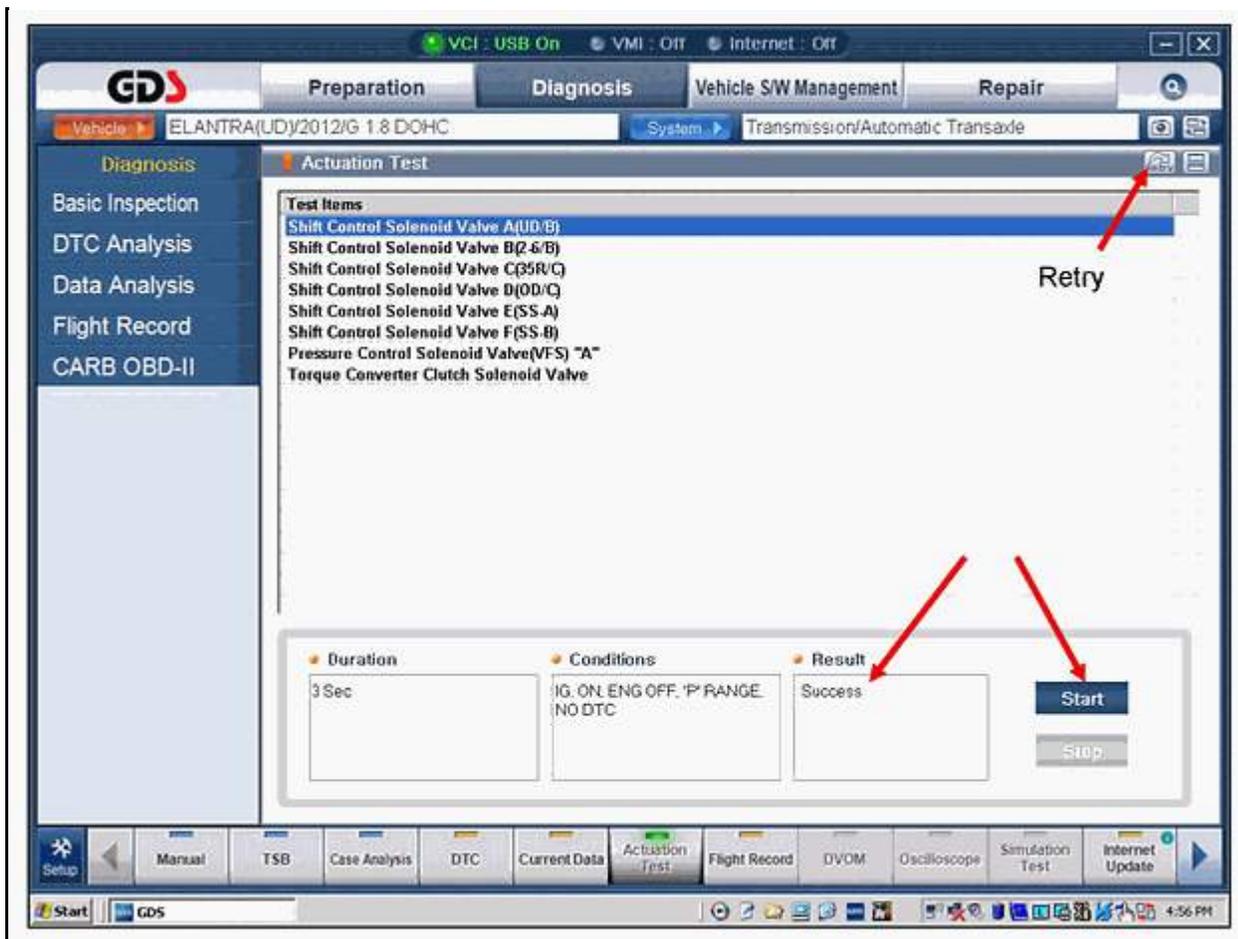
1. Using a GDS, check for DTC in the "Automatic Transaxle" menu. Record the DTC and description. Delete the DTC.
2. From the GDS, select the following parameters.
 - ^ Vehicle and A/T menu.
 - ^ "Actuation Test"

Press the "Start" button and look for a "Success" indication.

3. If the test results show:

^ "Success" - The GDS requested the TCM to activate the solenoids. Use chassis ears or stethoscope to listen for solenoid operation. If the solenoids are audible, the harness currently has no open/short circuit. Go to Step 5.

^ "Failure" - The GDS did not request the TCM to activate the solenoids. Click on the "Retry" button on the top right of the screen. If "Failure" is displayed again, go to Step 4.

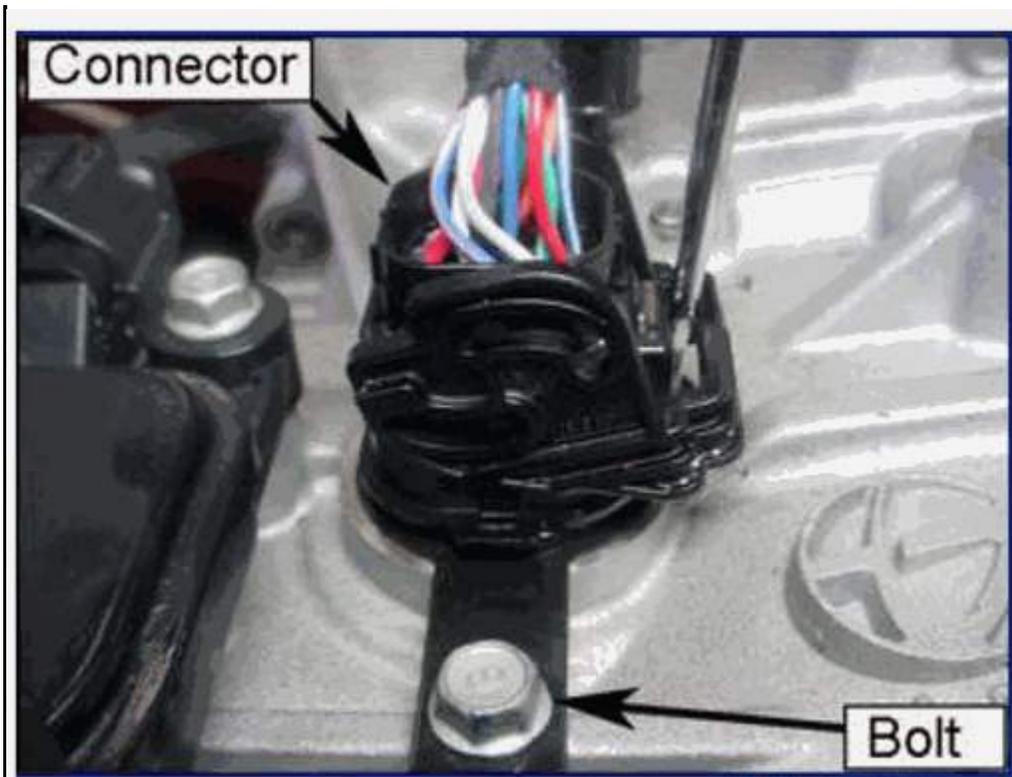
9. Use a screwdriver to release the tab and remove the solenoid connector on top of the case.
Remove the bolt that secures the connector and push the connector into the transmission.
Disconnect the vent hose on the top of the oil pan.

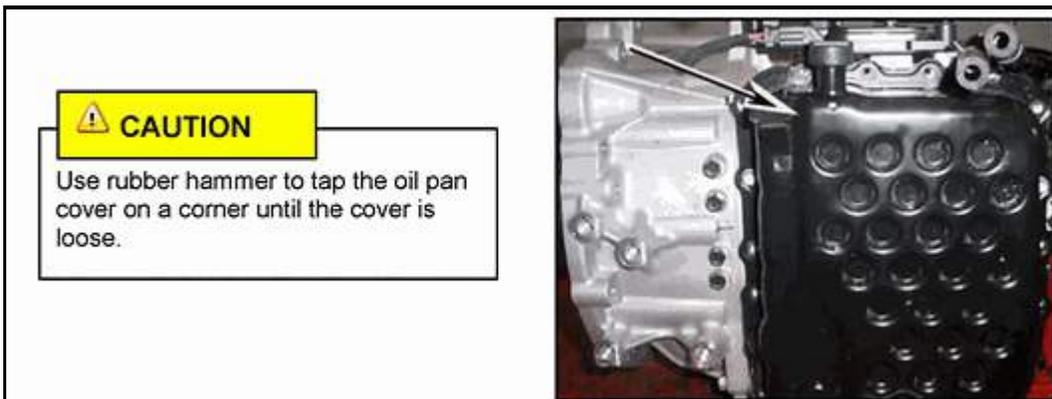
10. Remove the oil pan bolts and remove the pan.

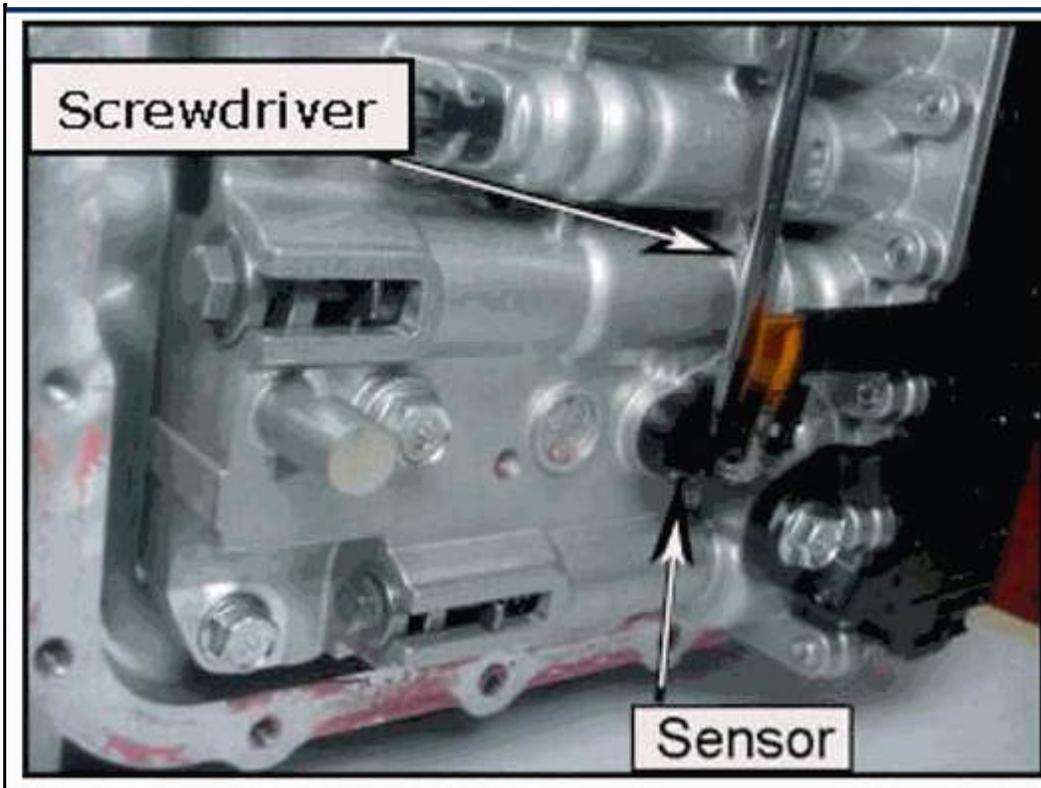
11. Use a small screwdriver to pry the connector from the oil temperature sensor (remove the sensor for vehicles with unified temperature sensor and harness).

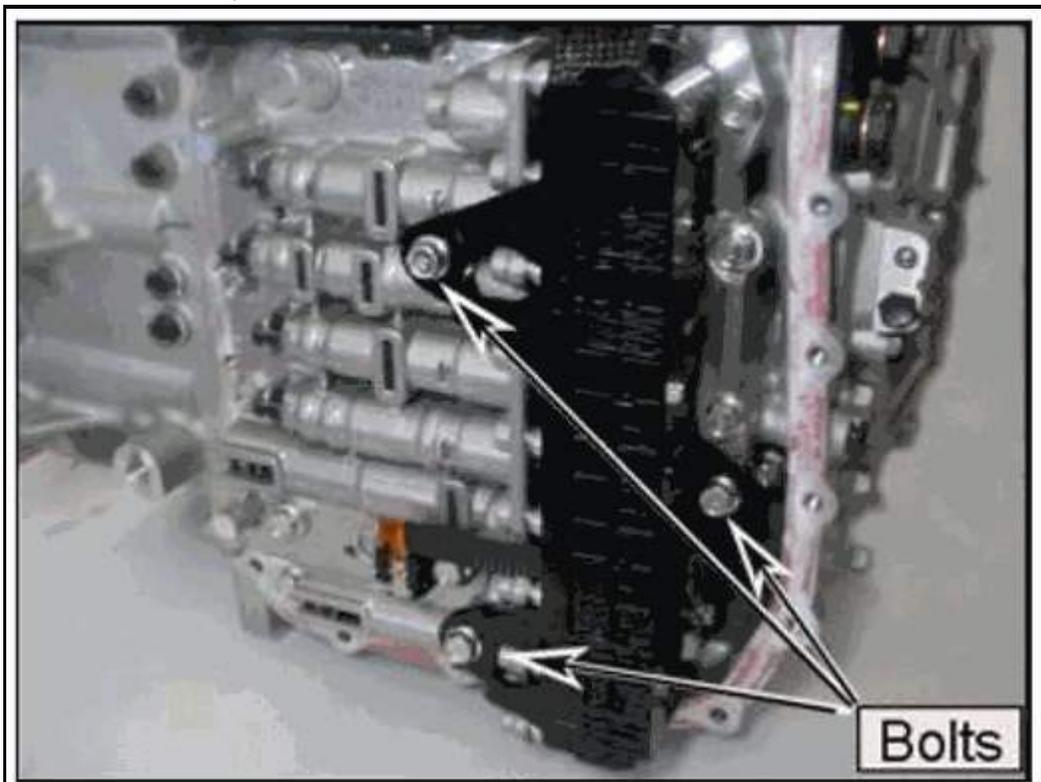
12. Remove three bolts to the solenoid valve connector.

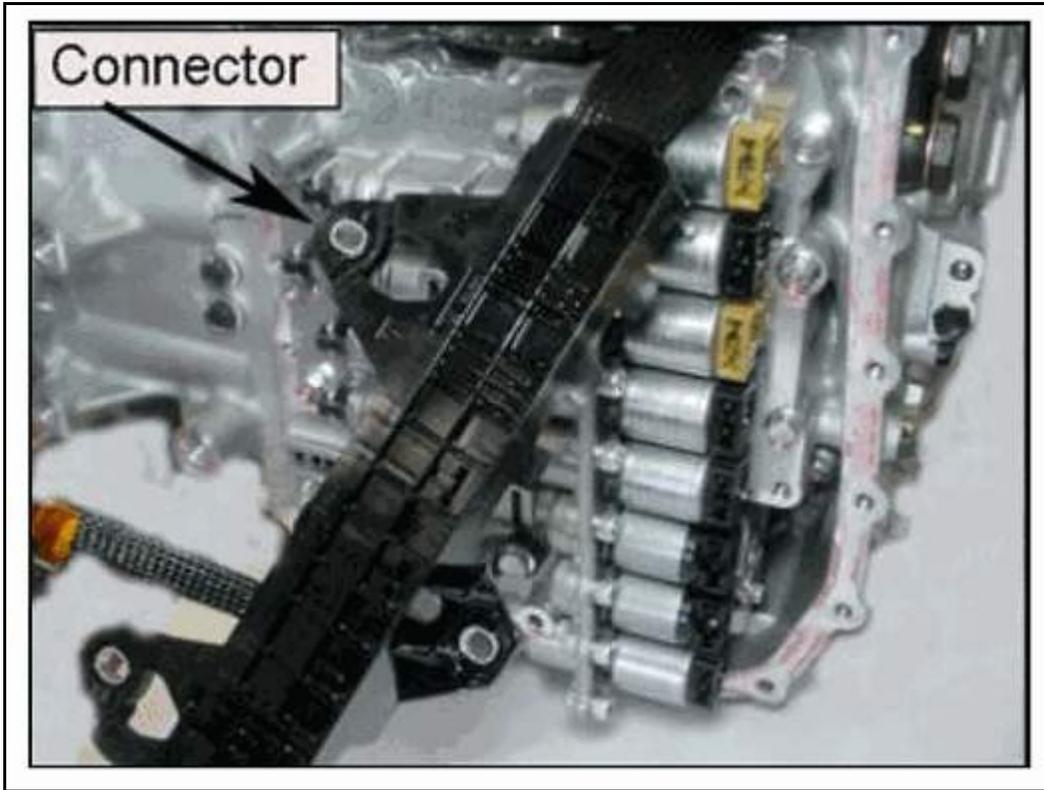
13. Pull the solenoid connector outward and move the connector out of position.

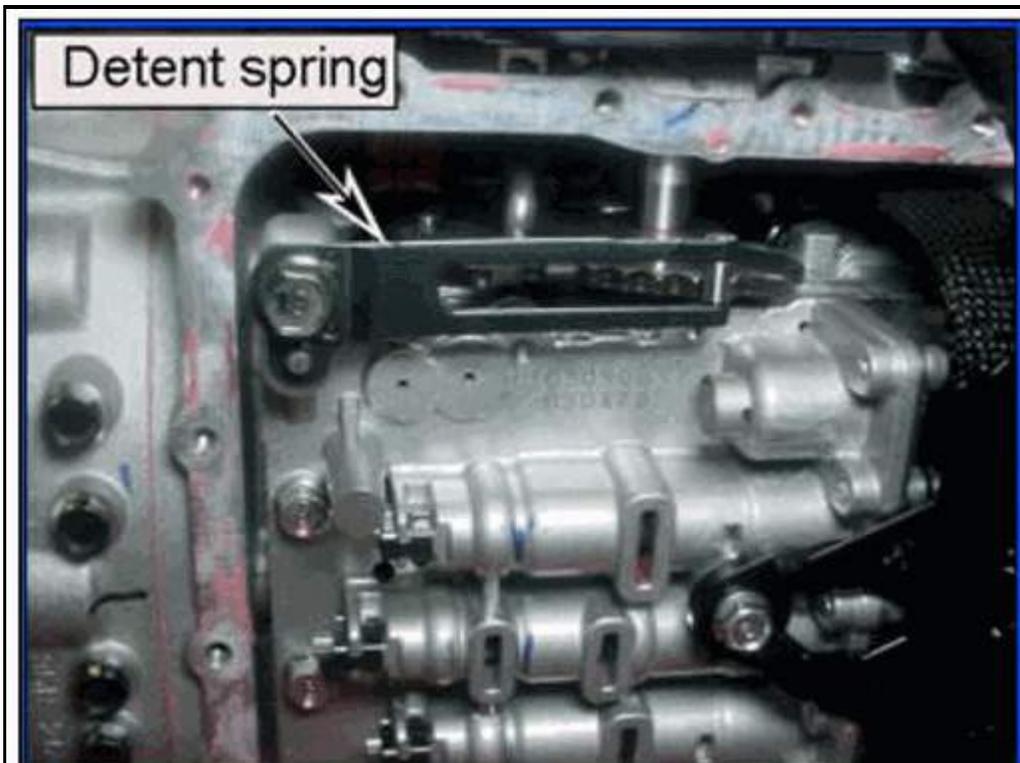
14. Remove the bolt that secures the detent spring and remove the spring.

Torque: 8~11 lb.ft (1.2~1.6 kgf.m)

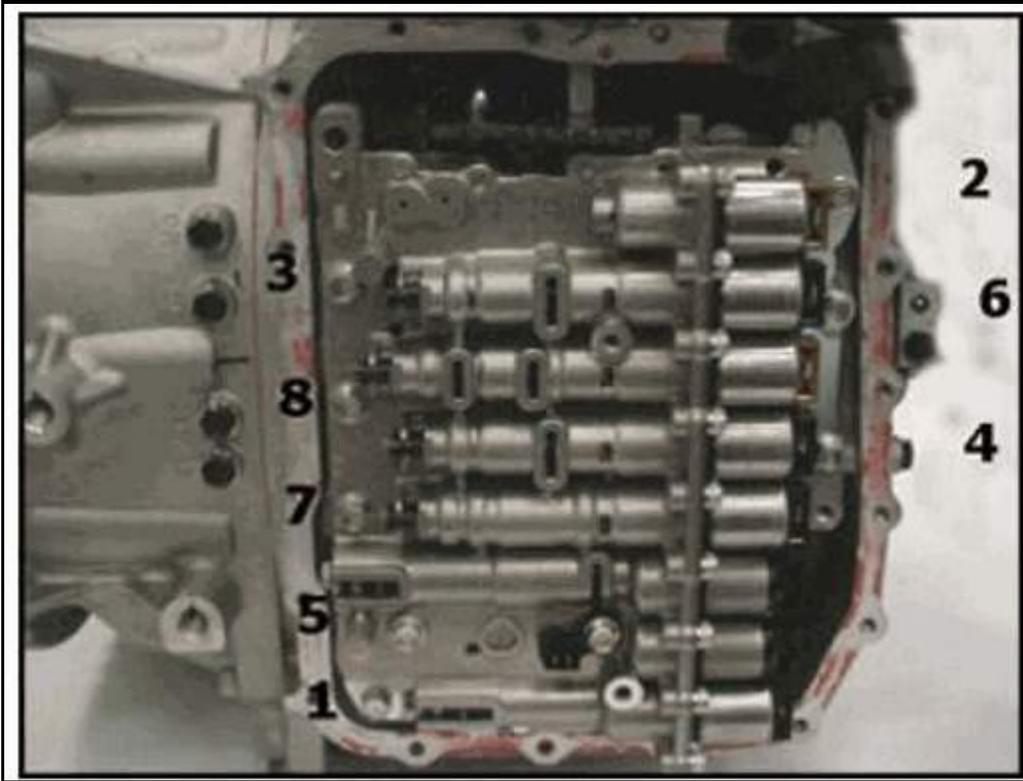
15. Remove the valve body bolts in the order shown and remove the valve body.

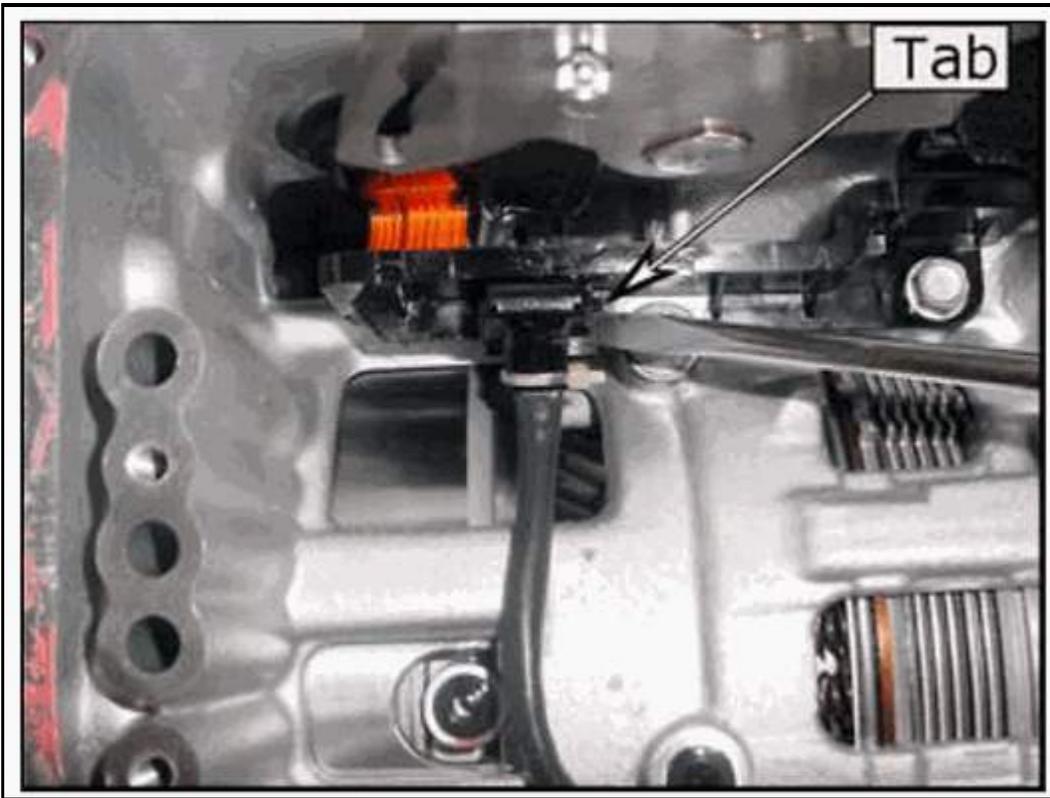
16. Use a screwdriver to depress the locking tab and pull outward on the connector to the input and output speed sensor.

17. Remove two bolts that secure the valve body harness to the case.

Pull the connector downward out of the case.

Install a new harness and insert the connector into the case. Attach the retainer and bolt on top of the case as shown in Step 9.

Install the bolts that secure the harness.

Torque: 7~9 lb.ft (1.0~1.0 kgf.m)

18. Use a 5mm hex socket and remove 9 Allen bolts that secure the solenoid support. Remove the solenoid support.

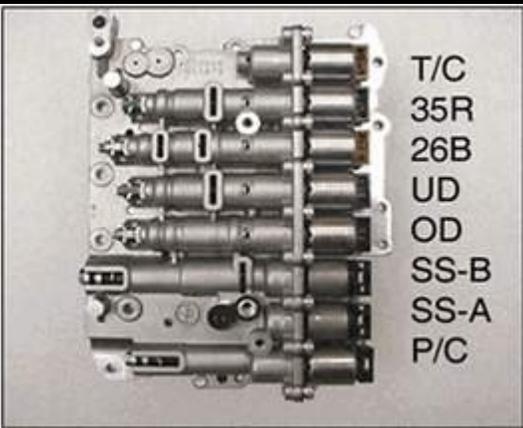
DTC		SOLENOID
P0741	T/C	TC solenoid (T/C)
P0743	T/C	TC solenoid (T/C)
P1778	T/C	HEV clutch solenoid
P0763	35R	Shift solenoid C (35R)
P0758	26B	Shift solenoid B (26-B)
P0753	UD	Shift solenoid A (UD)
P0768	OD	Shift solenoid D (OD)
P2709	SS-B	Shift solenoid F (SS-B)
P0773	SS-A	Shift solenoid E(SS-A)
P0748	P/C	P/C solenoid

19. Refer to the DTC recorded in Step 1 and replace the related solenoid.

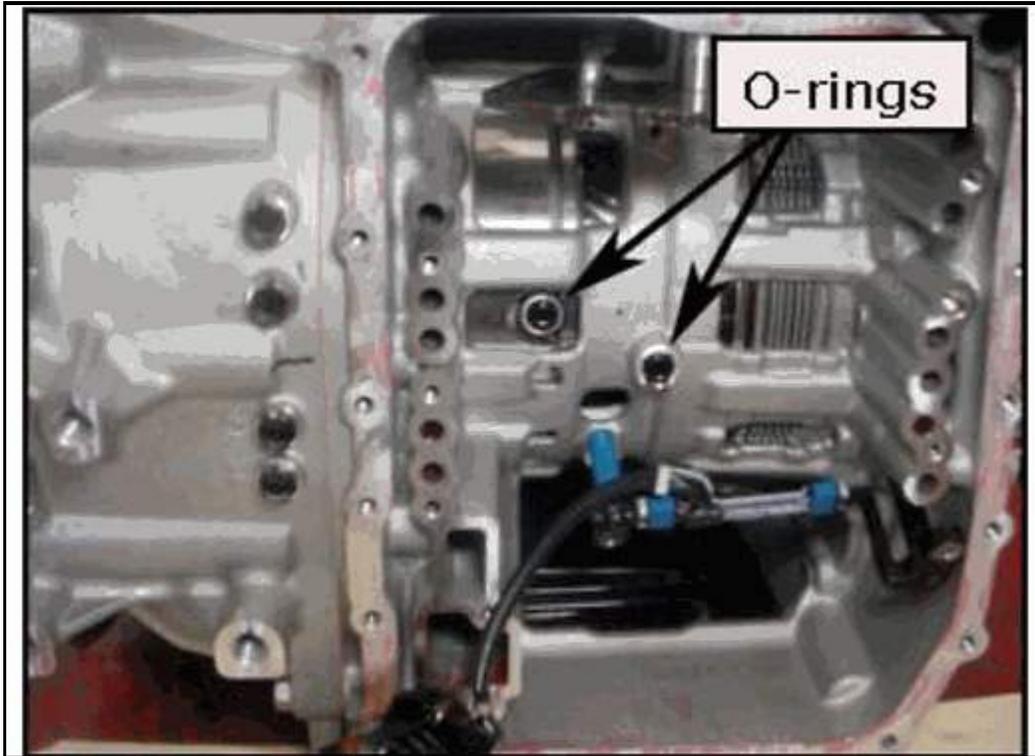
20. Confirm the O-rings are installed correctly in the case.

Reconnect the input and output speed sensor connector to the harness.

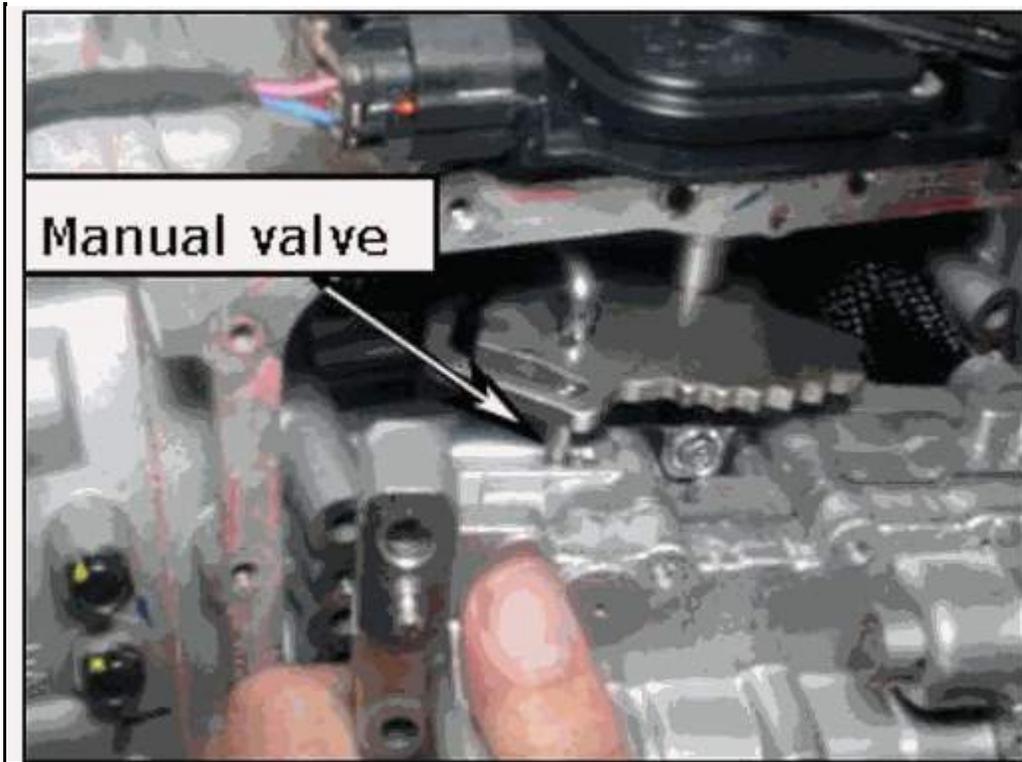
21. Align the manual shaft to the shift lever and install the valve body.

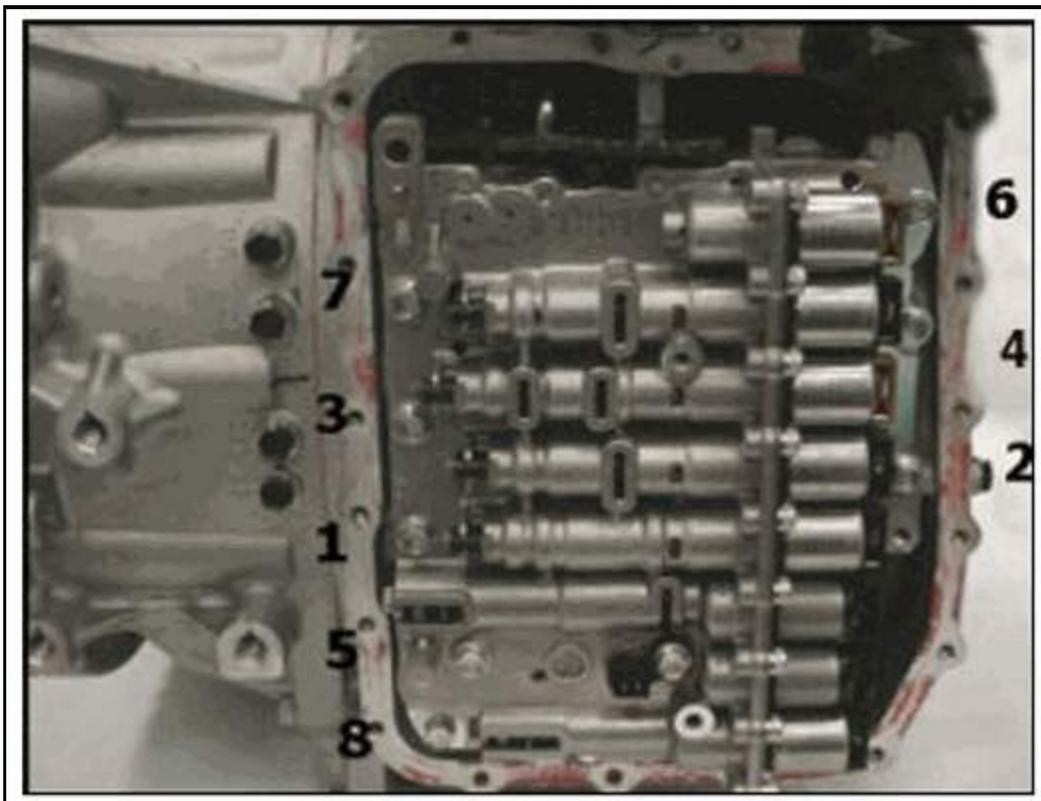
22. Install the valve body bolts and torque the bolts to specification in the order shown.

Torque: 7~9 lb.ft (1.0~1.2 kgf.m)

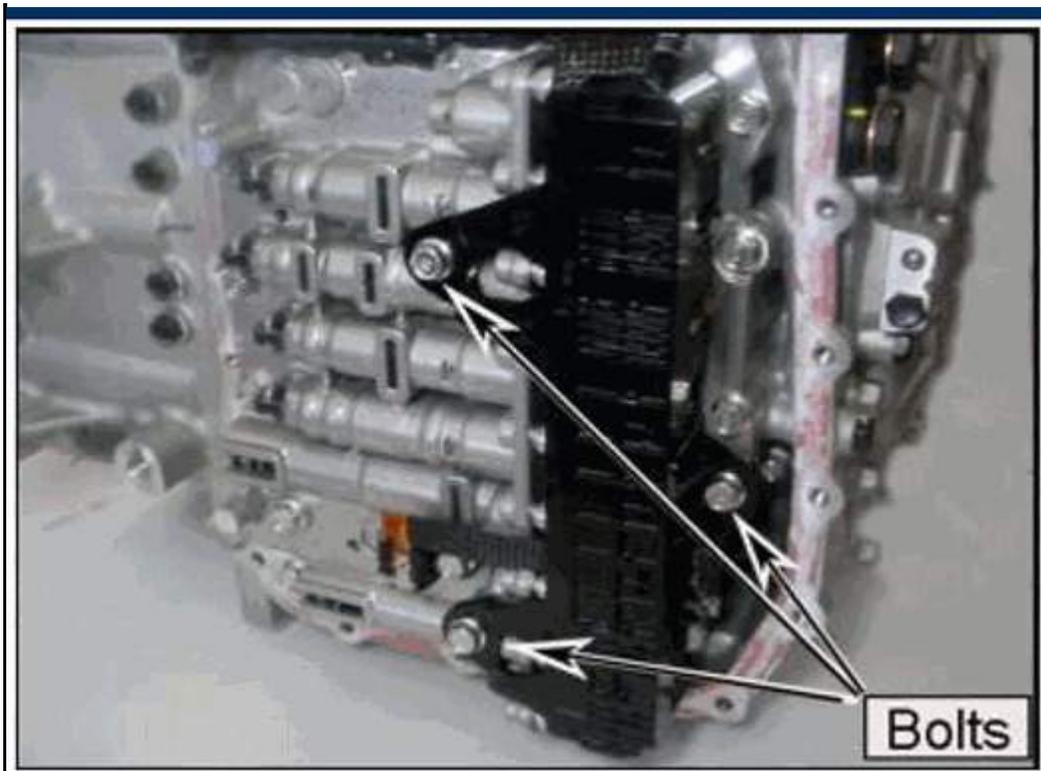
23. Reconnect the solenoid harness to the solenoids and oil temperature sensor.

Install the bolts to the solenoid harness connector and torque to specification.

Torque: 7~9 lb.ft (1.0~1.2 kgf.m)

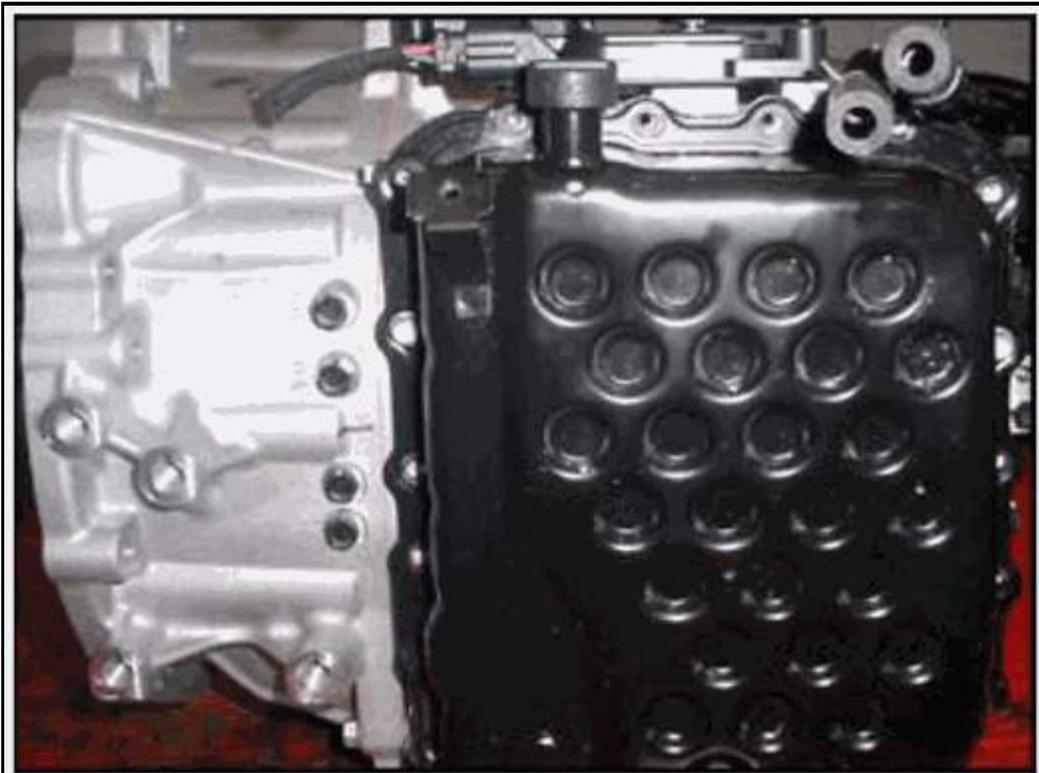
24. STEEL OIL PAN:

Apply Permatex Ultra Gray Sealer or Hyundai

Ultra Gray Gasket Sealer, P/N 00232-19039,
to the oil pan and reinstall the pan.

PLASTIC OIL PAN:
Install a new gasket to the oil pan and reinstall
the pan.

Tighten the bolts to specification.

Torque: 10~12 lb.ft (1.4~1.6 kgf.m)

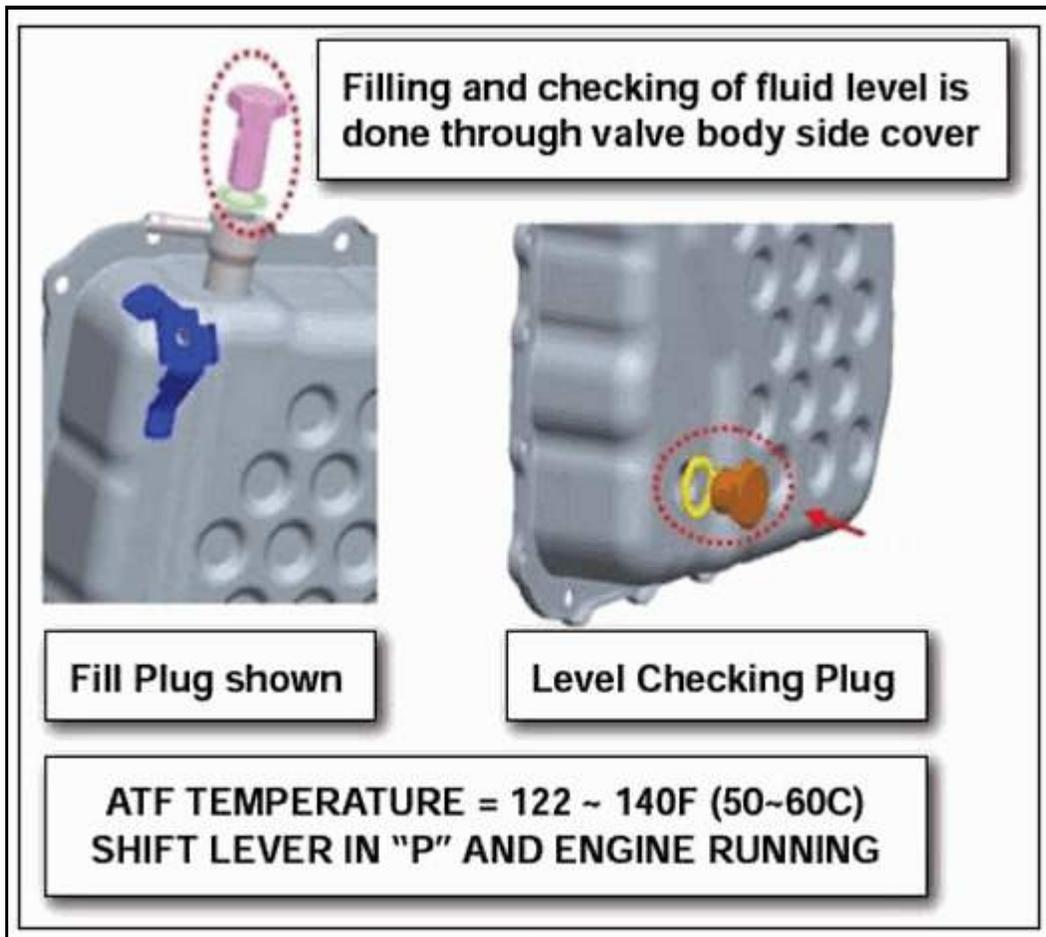
27. Remove the transaxle fill plug.

Use a funnel to add approximately 5~6 quarts of SPH-IV ATF through the fill plug opening. Reinstall the fill plug.

Attach the GDS to the DLC and select vehicle, A/T menu, Current Data and "Oil Temperature Sensor".

Start the engine and shift to Park. When the ATF is 122F~140°F (50~60°C), remove the level checking plug. The level is correct when oil flows out of the level checking plug in a thin steady stream.
